VERTICAL WALL INSPECTION USING SIDE SCAN SONAR

By Garry Kozak, GK Consulting

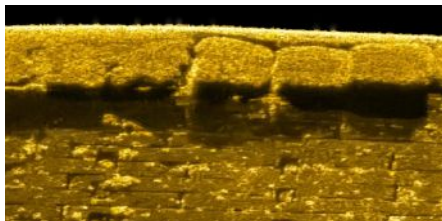
» Image 6

The resulting sonar imagery was of very high resolution allowing the viewing of every timber, seam, missing timbers, concrete cap deterioration (Image 6), outflow openings (Image 7), undercutting or areas of non-support of cribbing wall (Image 8), etc. The results exceeded all expectations of the engineering company and met all their inspection requirements. This trial conclusively showed that with the right field data collection technique, side scan sonar is a very effective tool for vertical wall inspections.
