VERTICAL WALL INSPECTION USING SIDE SCAN SONAR

By Garry Kozak, GK Consulting

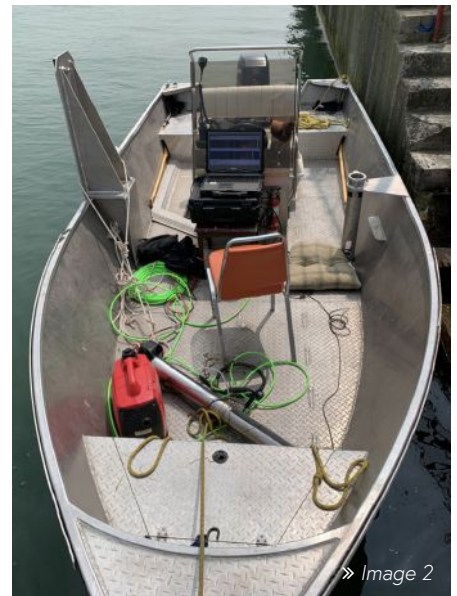
» Image 2

Pole mounting of the side scan sonar and rotating the fish in the pole mount bracket to position the transducer at an optimum angle for imaging the wall would be a perfect setup. However, since the small boat (Image 2) we collected the data out of had no pole mount, the towfish was simply hung on a rope off one side of the boat, 1 meter in depth and towed. No rotation was done to the towfish transducer. Since the sidescan sonar vertical beam is so wide, not rotating the transducer in practice had no negative effects on the quality of data collected.

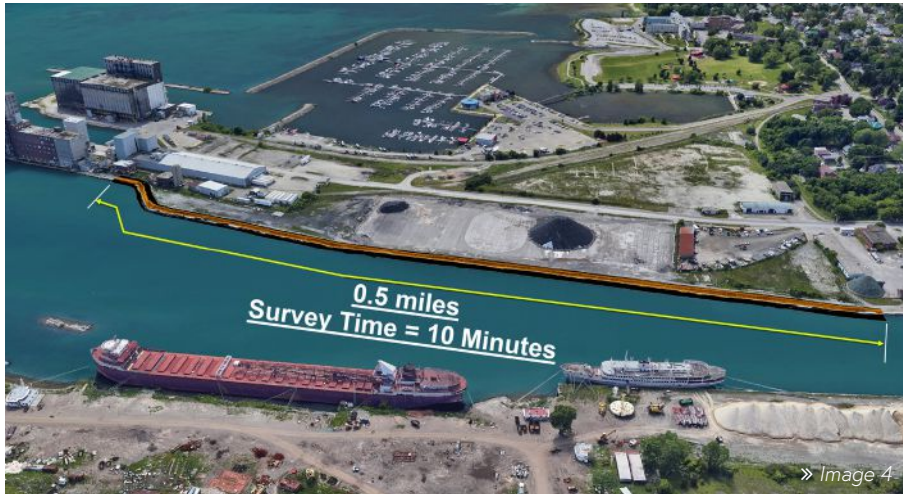
» Image 4

A single survey track was made in front of the wall maintaining the towfish about 1 to 2 meters from the wall face. The length of wall that was required to be inspected was 0.5 miles and the scan was completed in 10 minutes (Image 4).
